UNITED STATES ENVIRONMENTAL PROTECTION AGENCY

Subject: Hamburg - Port Clinton Avenue Site
Hamburg Borough, Berks County, Pennsylvania

Date: March 12, 2002

Hamburg - Port Clinton Avenue Site
Hamburg, Berks County, Pennsylvania

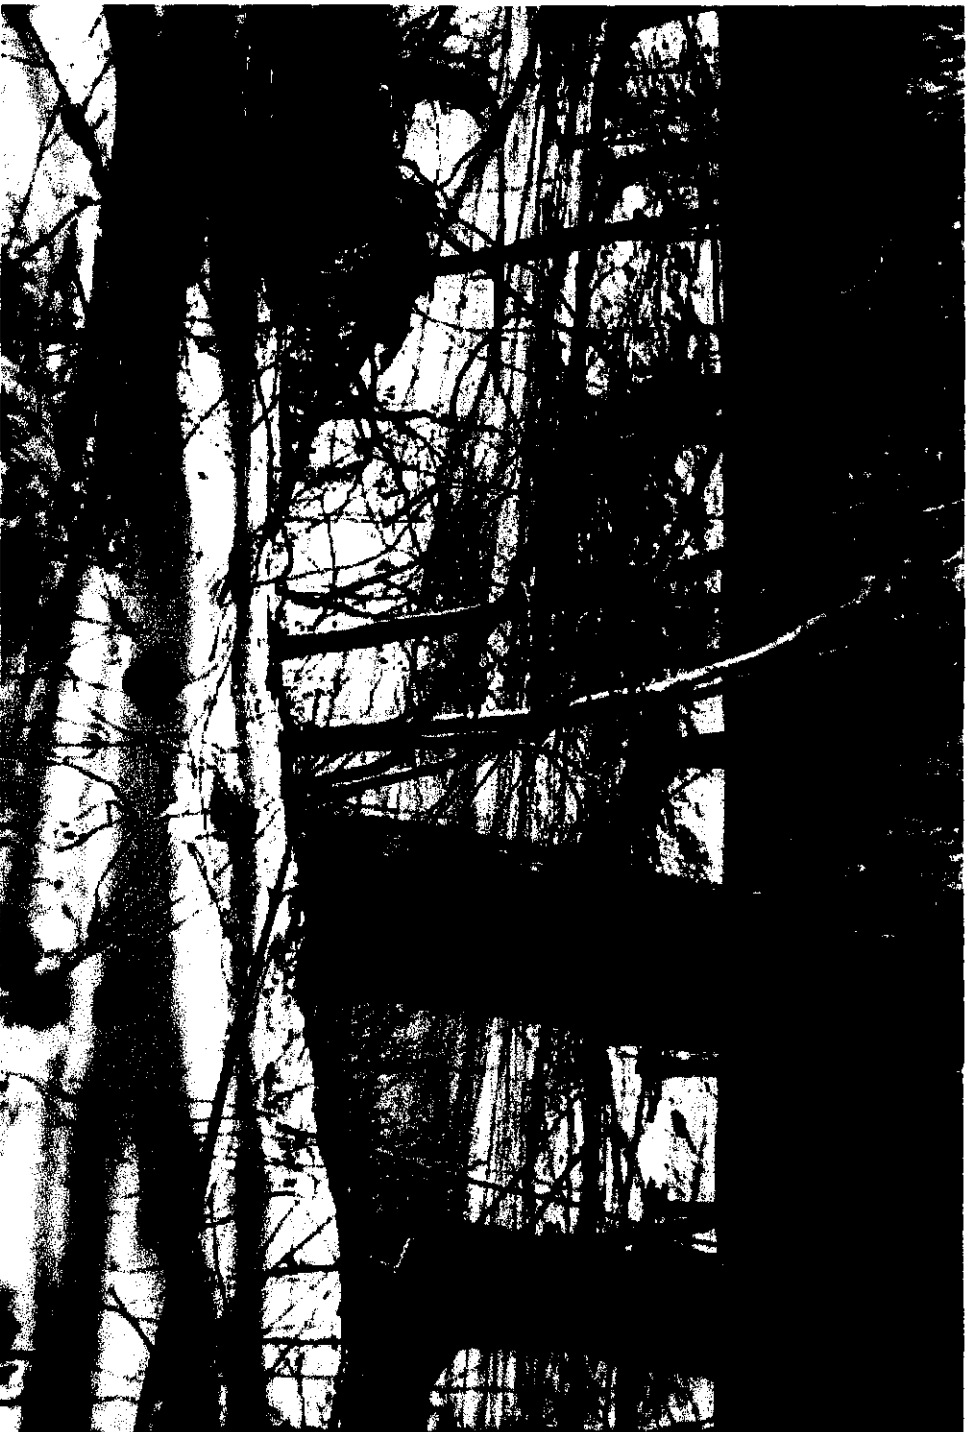
Photograph 3

Description: Sampling location SCT-SS-100; analytical results indicate 101,990 ppm lead in the sample at this location.

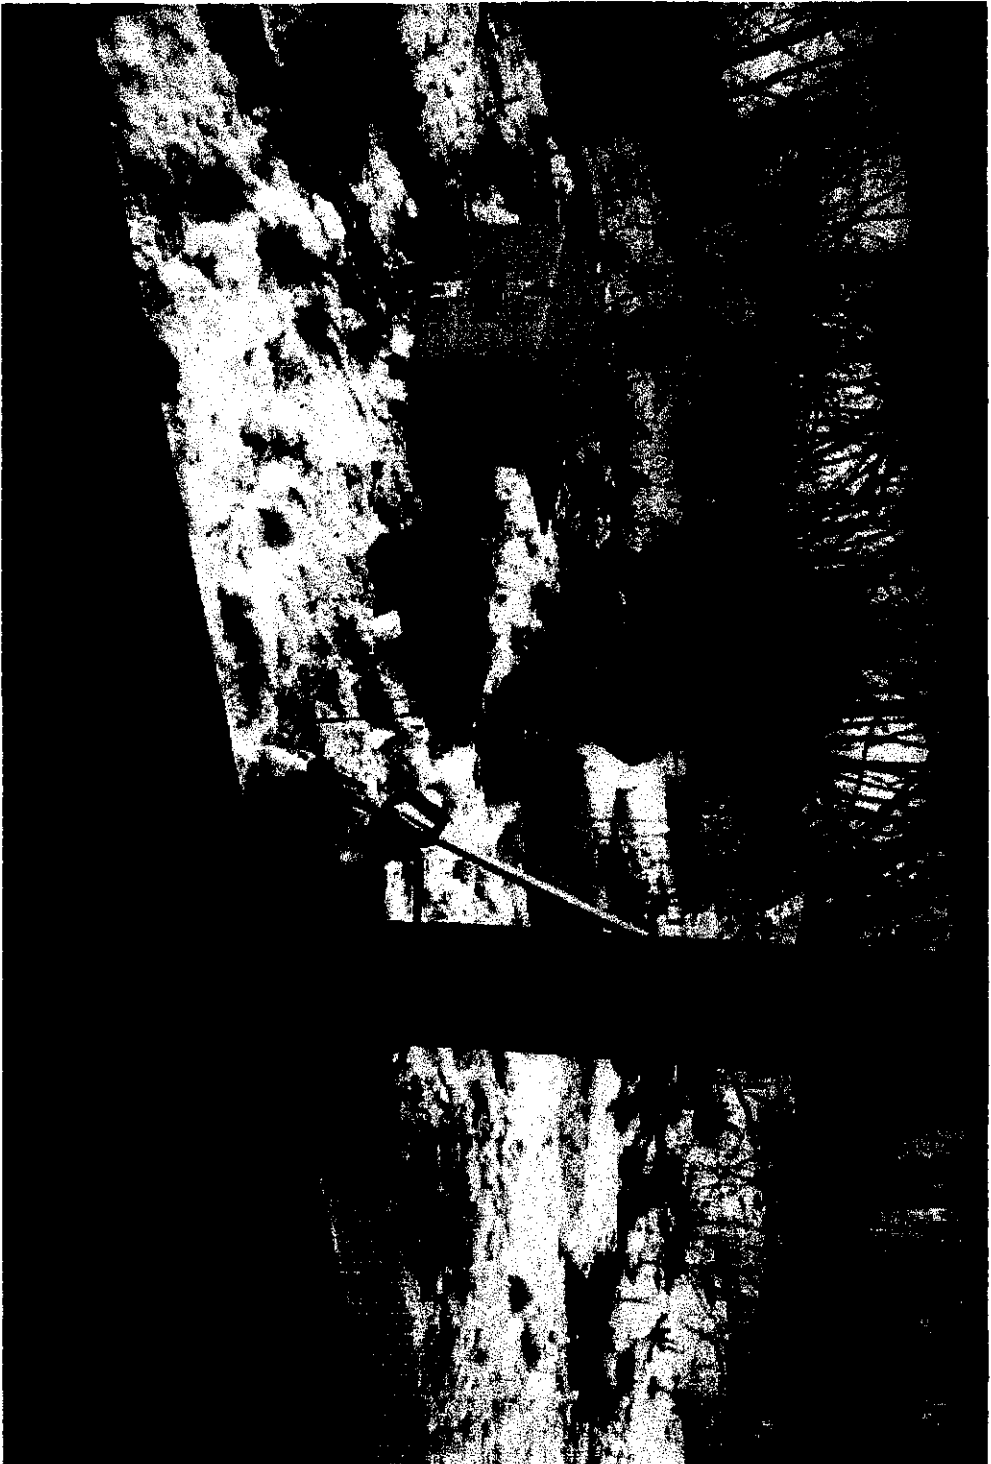
Photograph 4

Description: Sampling location SCT-SS-111; note the proximity to Port Clinton Avenue; analytical results indicated 19,200 ppm lead in the sample from this location.

Crushed battery casings were used as fill in various areas of the Borough and in areas adjacent to the Borough of Hamburg. Battery casings are present at the soil surface along Port Clinton Avenue. A pile of battery casings is located at the south end of the site (sample locations SCT-SS-110 and SCT-SS-111). Battery casing chips are exposed along Port Clinton Avenue at the south end of the site near the guardrail (see photographs). High lead concentrations and battery casing waste is evident at the Hamburg - Port Clinton Avenue site. No methods of containment are in use at this time.

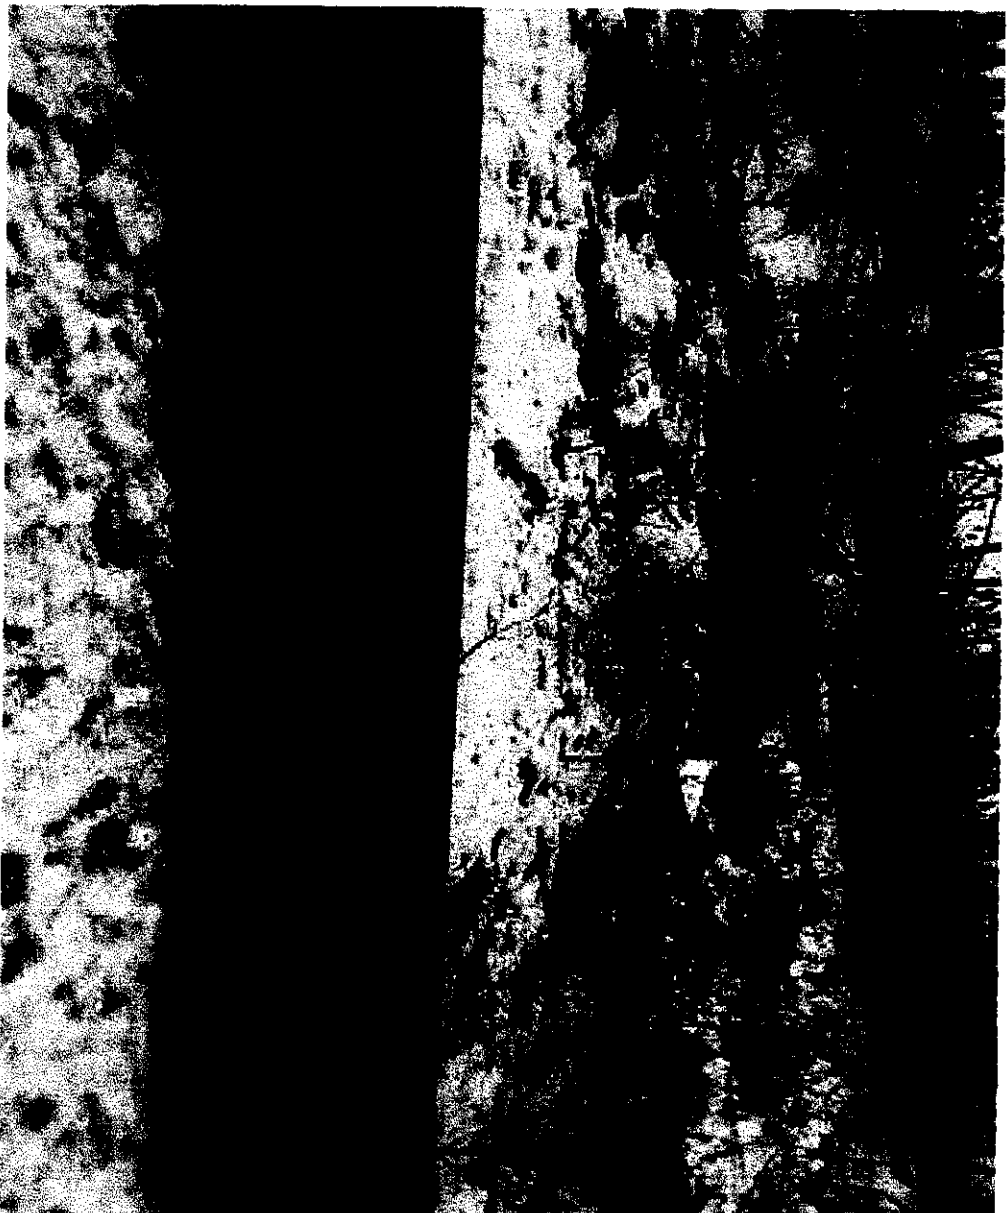
Photograph 5

Description: Sampling location SCT-SS-109; note proximity to Port Clinton Avenue.

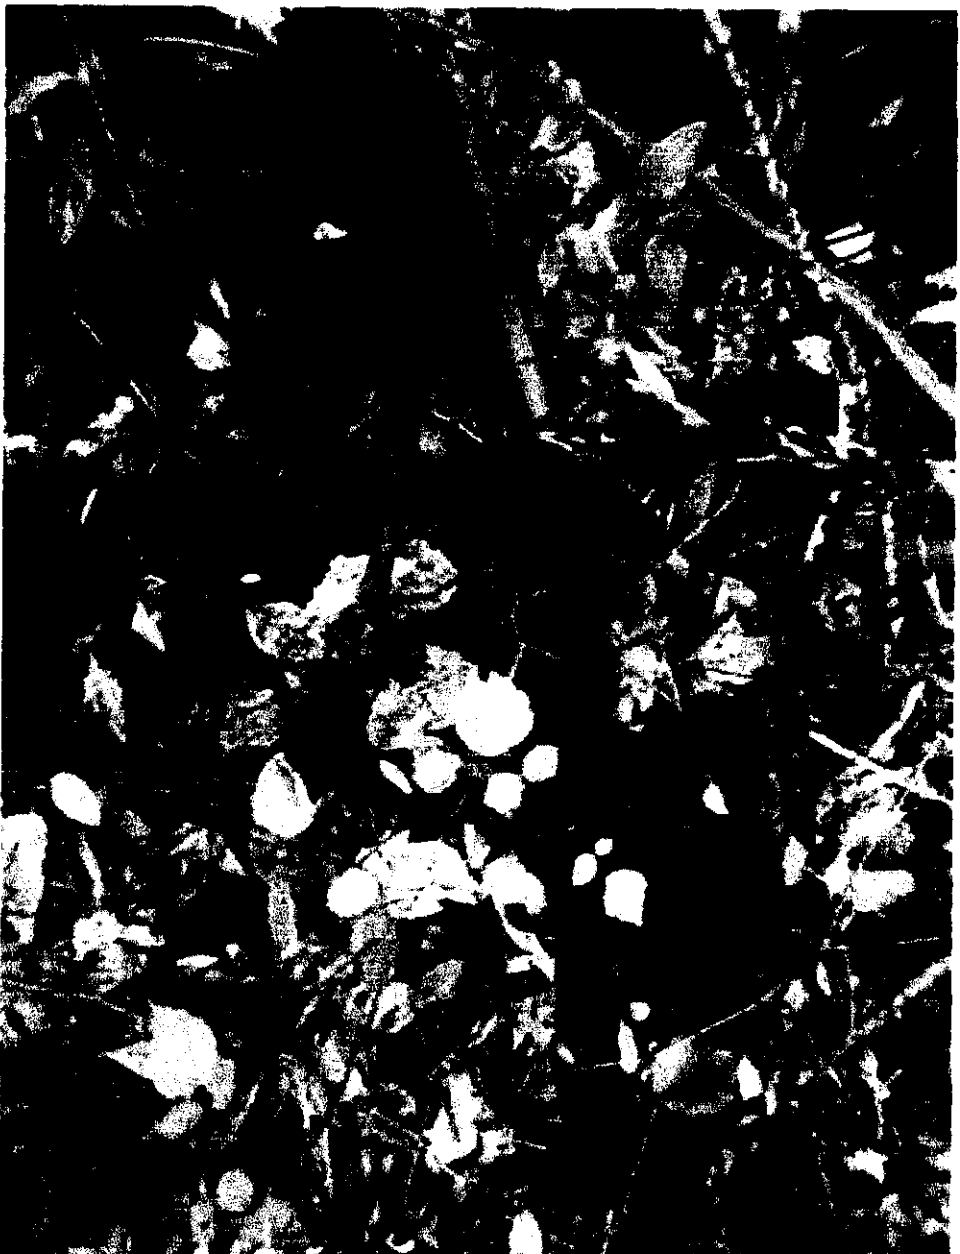
Photograph 6

Description: Batteries at surface at Sampling location SCT-SS-110; analytical results indicate 1,430 ppm lead in the sample from this location.

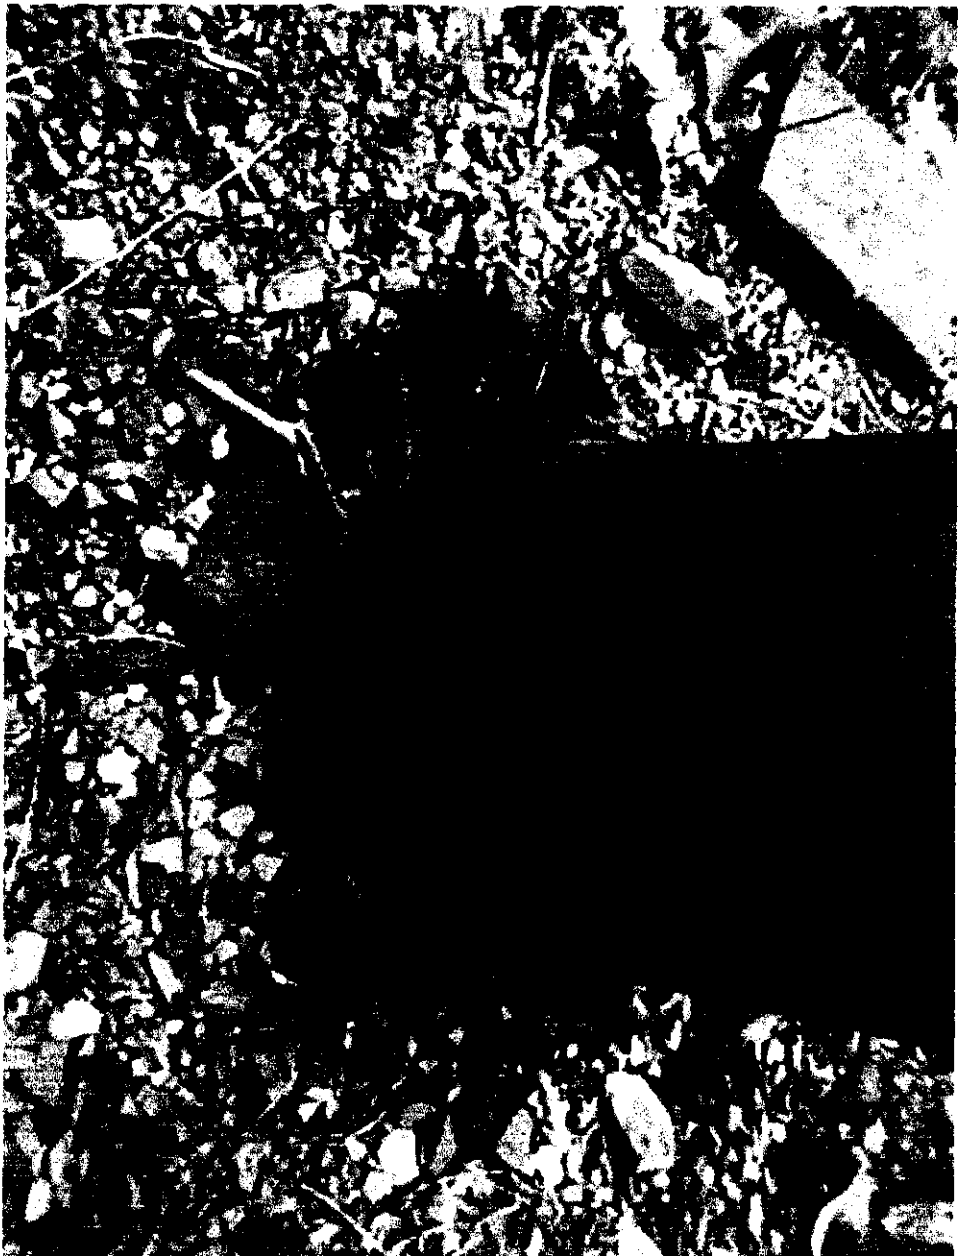
Photograph 7

Description: Battery chips at base of phone pole along Port Clinton Avenue.

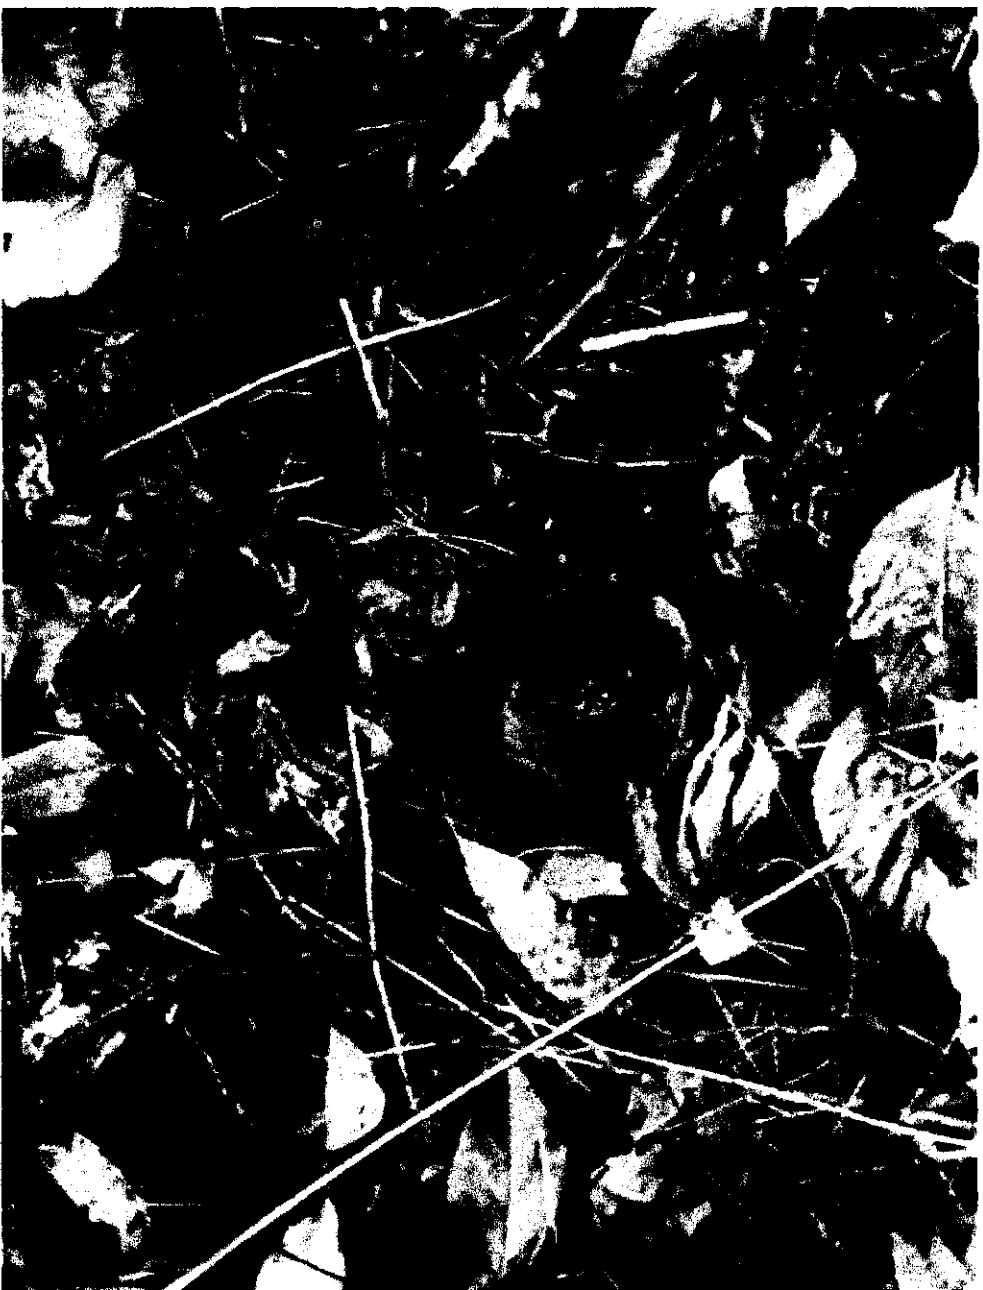
Photograph 8

Description: Battery chips on soil surface along Port Clinton Avenue.

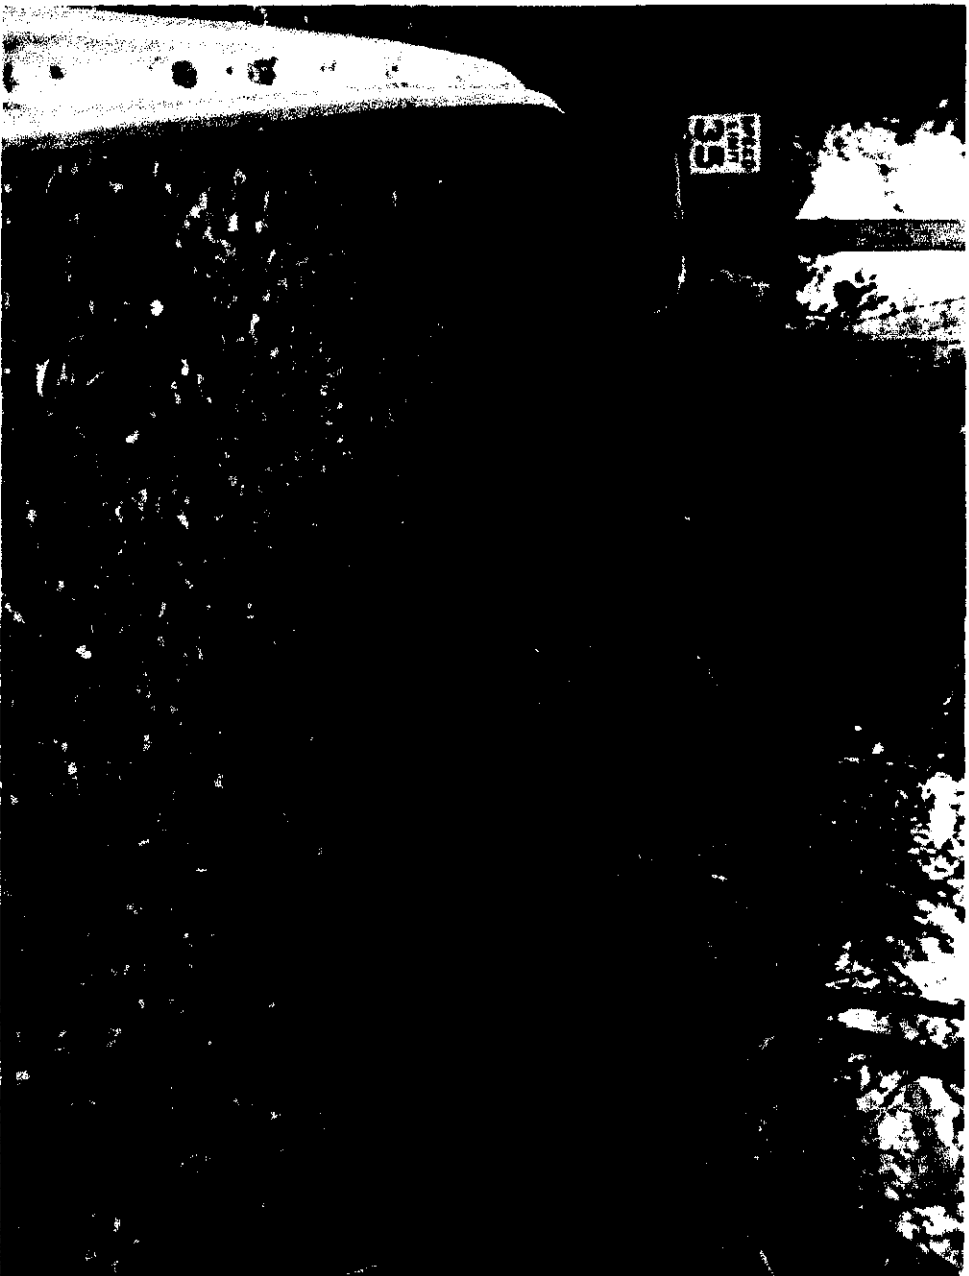
Photograph 10

Description: Area to right of guardrail is location of samples SCT-SS-110 through SCT-SS-112.
